PART 573 Defect and Noncompliance Report 99V-090 (01)

DMC Recall Identification Number: EBB-001-99

Make(s): Daewoo Model years involved: 1998/1999 Model(s): Lanos

This noncompliance is the result of incorrect positioning of the Door Pad on the door side impact beam during vehicle manufacturing (refer to attached Manufacturing Standard Drawing).

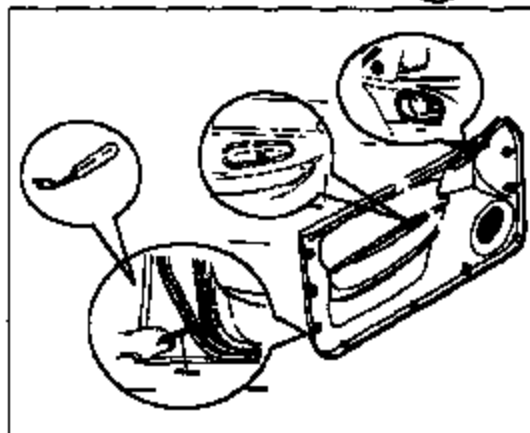
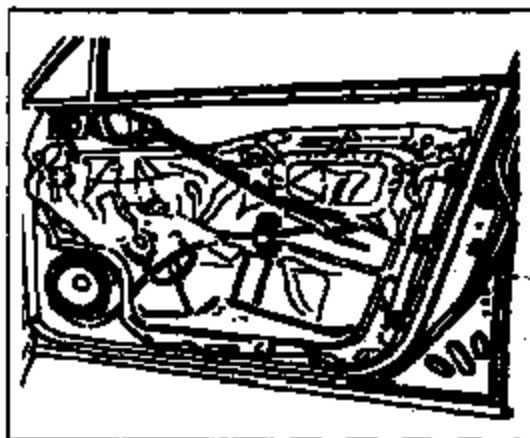
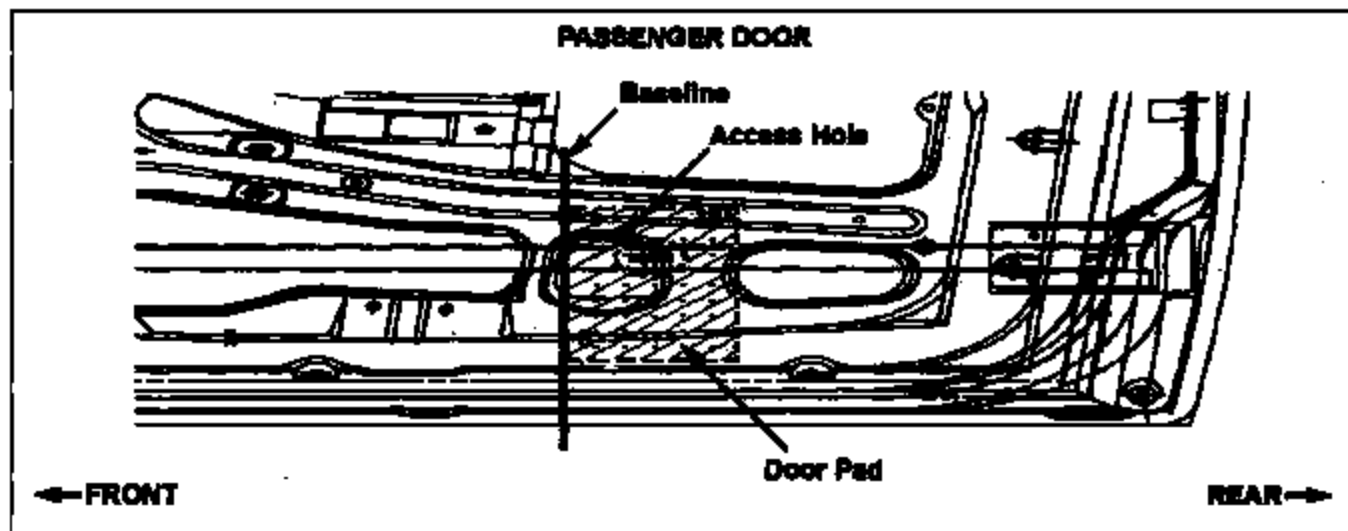
In specific Lanos 3 Door Hatchback models, the Door Pad is incorrectly positioned during the vehicle manufacturing process near the door latch mechanism (rearward in the door assembly). In Lanos 3 Door Hatchback models that have been correctly manufactured, the Door Pad is positioned mid door (refer to attached Manufacturing Standard Drawing).

1. Remove the four (4) door panel retaining screws.
2. Using a suitable door panel removal tool, remove the side mirror interior trim panel and the inner door release handle trim bezel.
3. **Lanos S models only** - Using a suitable release tool, remove the retaining clip and remove the window crank handle.
4. Using a suitable door panel removal tool, carefully release the door panel retaining clips and remove the door panel from the door.
5. Starting from the rear of the door, carefully remove the plastic moisture barrier from the rear portion of the door until the center of the door is exposed.

6. Verify that the door pad is correctly positioned according to the illustration provided above. If the door pad is not positioned correctly, slide the door pad along the tubular side impact beam until the correct position is achieved.
7. Reinstall the plastic moisture barrier, door panel, retaining screws, window crank handle (if equipped) and door trim items.
8. Roll the window up and down and insure the correct operation and positioning of the window and door handles.

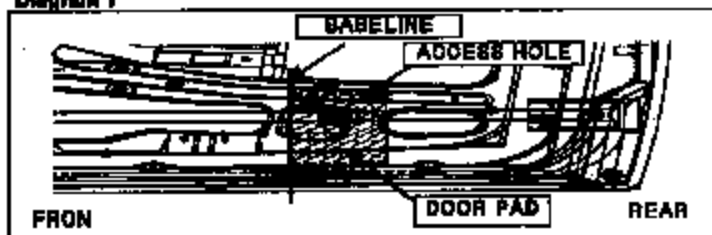
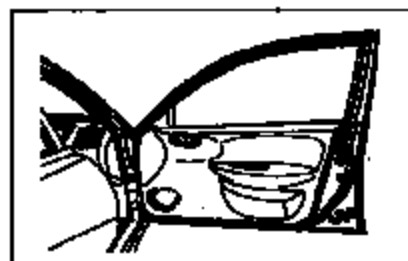
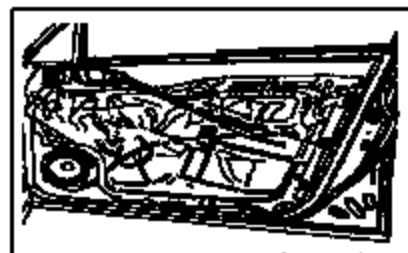
Diagram 1

As a result of our investigation we found that the absence or misinstallation of the Door Panel was caused by improper controls in the vehicle production line. In the Lanos 3-Door Hatchback you will find that the Door Pad is out of position or the Door Pad is missing. In the Lanos 4-Door Notchback the Door Pad is missing.

1. Door Trim Panel Removal:
 - a. Lower the front window.
 - b. Remove the door pull screw.
 - c. Pry off the Inside Door Handle Trim Bezel.
 - d. Remove the screws on the base of the Trim Panel.
 - e. Pry off the Trim Panel using the Door Trim Remover (KM-475-B).
2. Remove the door screws and the pull bracket.
3. Remove the Door Seal Trim.
4. Inspect the position of the Door Pad in the front Door Panel. Relocate the Door Pad to the end of the part of access hole as shown in the diagram 1.
5. After completion of the repair place a punch mark above the second digit of the VIN (in this case over the letter "L") stamped into the Bulkhead in the engine compartment.
